## Brownfields and greenfields

Tata Steel: Protact® production line enclosure

Upgrading older cranes to current standards

## Newsletter of TCS / November 2017

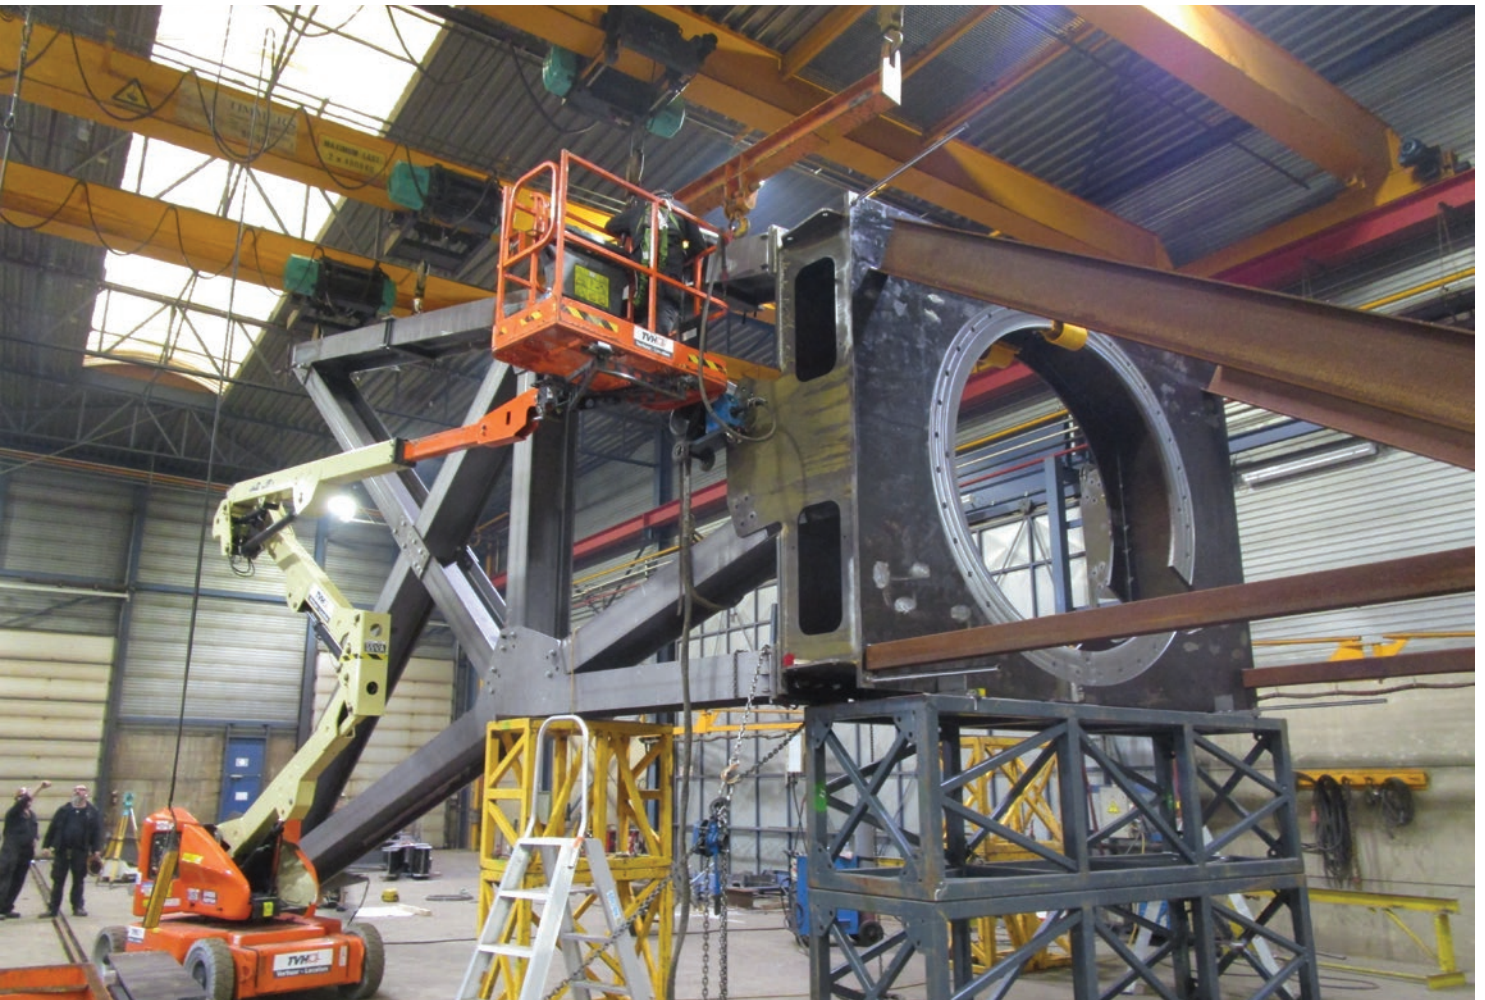
▲ Fatigue-proof design and construction was crucial, and in addition deflections at the top of the structure had to be kept to less than 1 millimetre

Vibrations were a major preoccupation in a recent project carried out for a plant in Turkey. “TCS was charged with designing and constructing the supporting steel structure of a new production unit,” Dirk Teuwen explains. “At the core of the production line is a large melting pot where recycled material is melted and kept at a boiling temperature above 1700°C. The pot is like a giant bubbling jacuzzi, inducing hefty but hard-to-predict vibrations along a broad frequency spectrum, and in different directions. These vibrations are transferred to the 13-metre high supporting steel structure, which has a 6 by 5-metre base. Fatigue-proof design and construction of this steel structure was crucial, and an additional challenge was the comfort requirement to keep deflections at the top of the structure to less than 1 millimetre.”

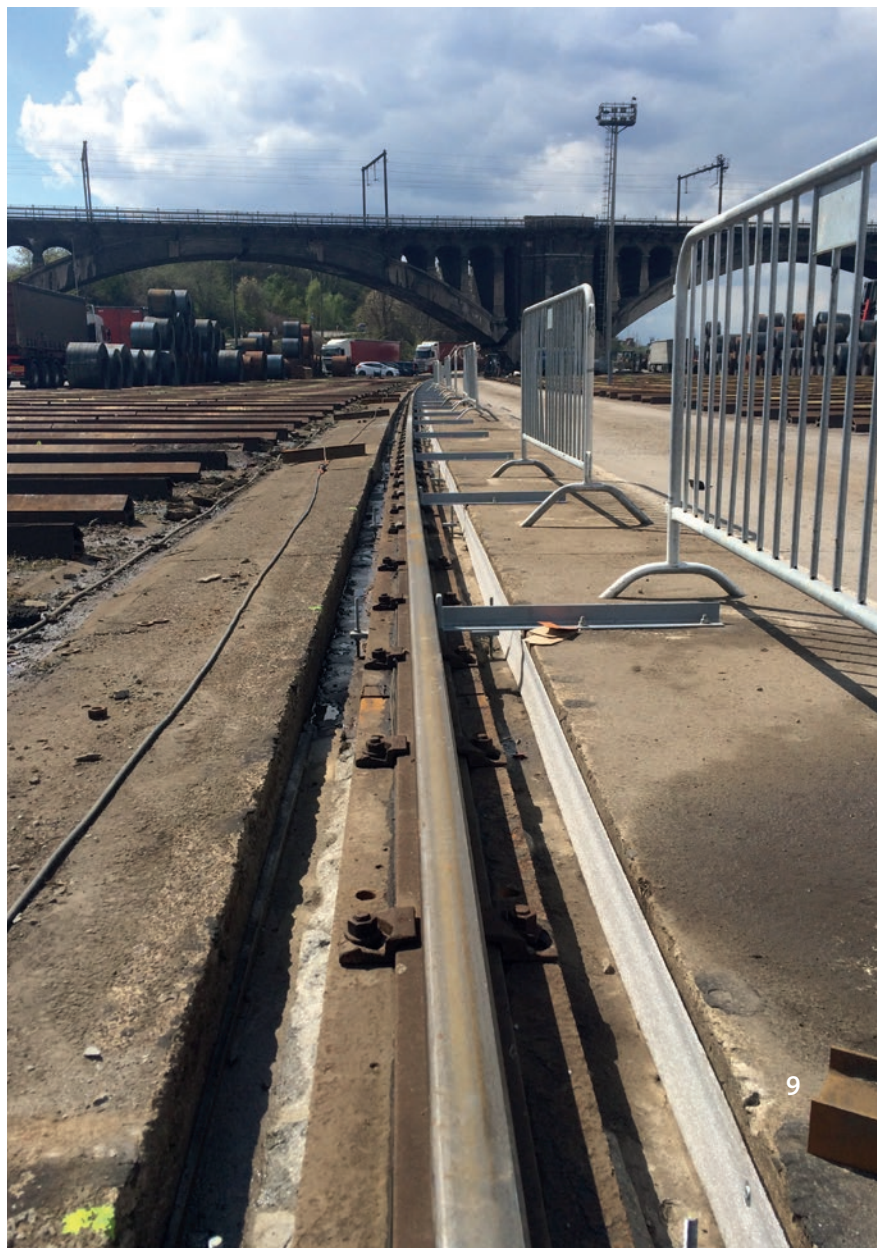
The sagged rail was taken away to allow the foundations ►  
to be reinforced and levelled out, before it was refitted and  
precisely re-aligned.

The sagged rail was taken away so that the foundations could be reinforced and levelled-out, before it was refitted and precisely re-aligned. The trolley rails of Crane 2 were replaced with new ones. In addition, a plan was made to further modernise both cranes. Electrical equipment and cabling is soon to be replaced and LED lighting will be installed to improve safety and operating comfort. “That will bring our old cranes right up to current safety, performance and reliability standards,” concludes Van Geneugden.

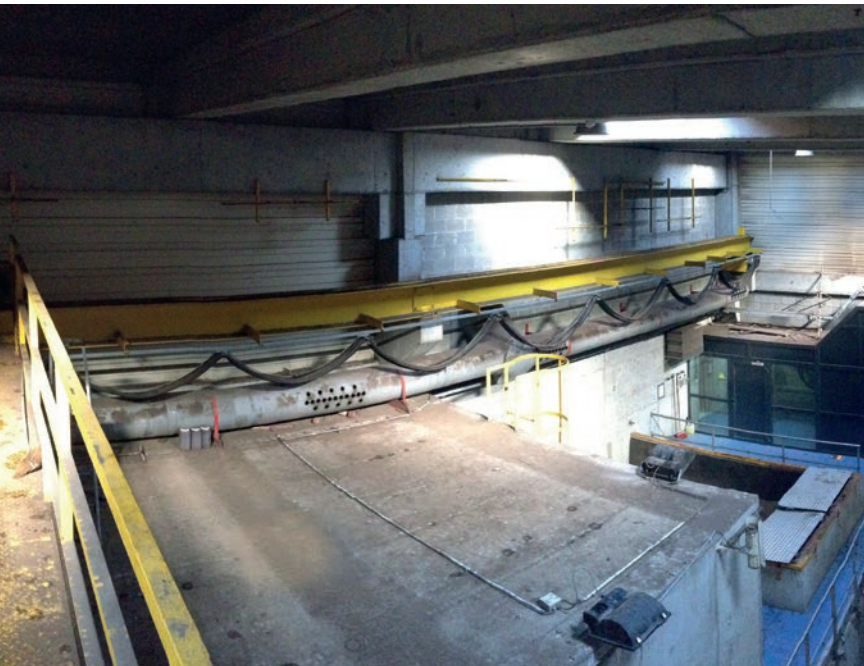
- ▼ Worn-out cabling was replaced and electrical equipment upgraded.

▲ Before renovation.

A slightly different story reinforced the point at Aquafin’s Deurne water treatment station in Deurne, where the electric cabling of a 1980s-era overhead travelling crane was completely worn out due to year-round exposure to a corrosive atmosphere containing methane and hydrogen sulphide. Maintenance manager Georges Peters explains: “The crane is critical for us during the plant shutdown period when it is used for maintenance. But we were increasingly worried about its poor reliability, and especially the condition of the electrical cables, which had caused a number of equipment breakdowns in recent years. Following the latest incident, we issued a request for quotation among crane service providers. TCS provided the best offer, convincing us that they would be able to replace the cabling before the crucial plant shutdown period and at the same time also upgrade the associated electrical equipment. They lived up to their promise. It is comforting to know that our old machine is now as reliable as ever.”

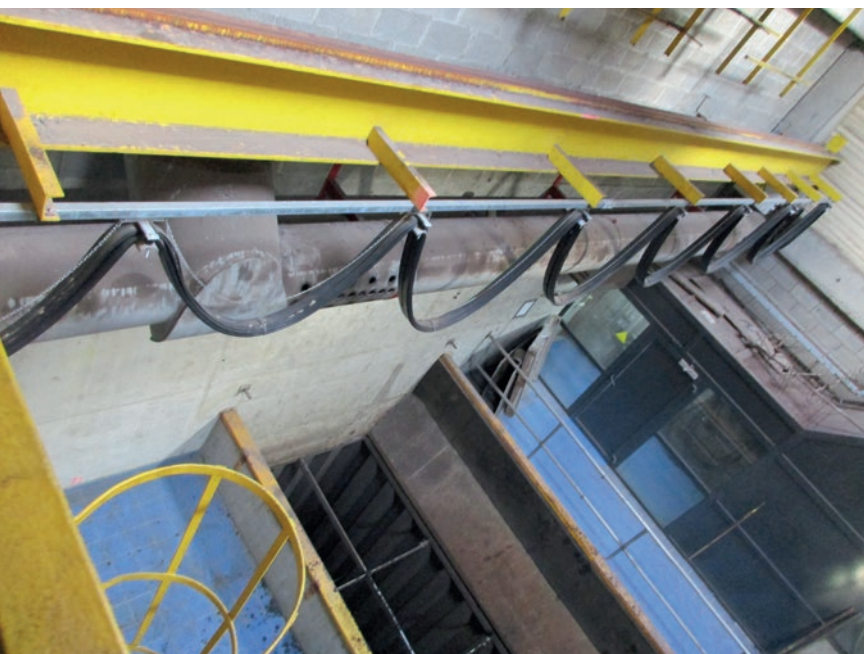
▲ After renovation.

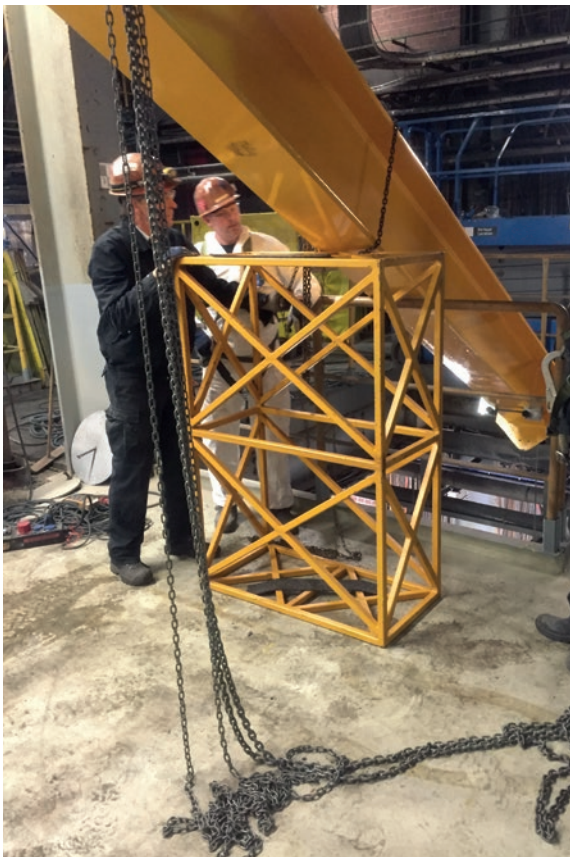
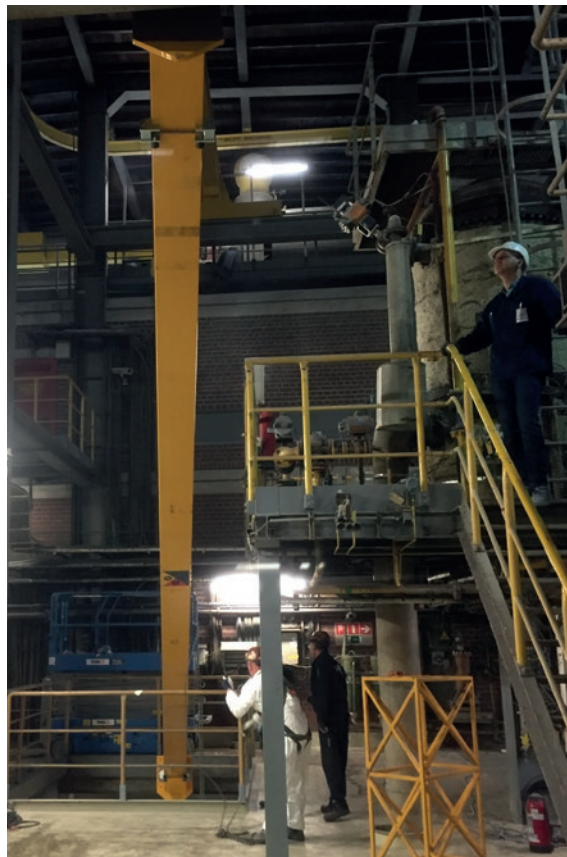
◀ Assembly conditions were difficult and manoeuvring space was tight.

components needed to be replaced. Importantly, TCS proposed further modifications to bring the technology up to current standards, improve maintainability and the accessibility of critical components, and simplify problem identification. What’s more, TCS was the only company willing and able to carry out this renovation, as other firms had backed off because of the difficult assembly conditions and the tight manoeuvring space.” ■

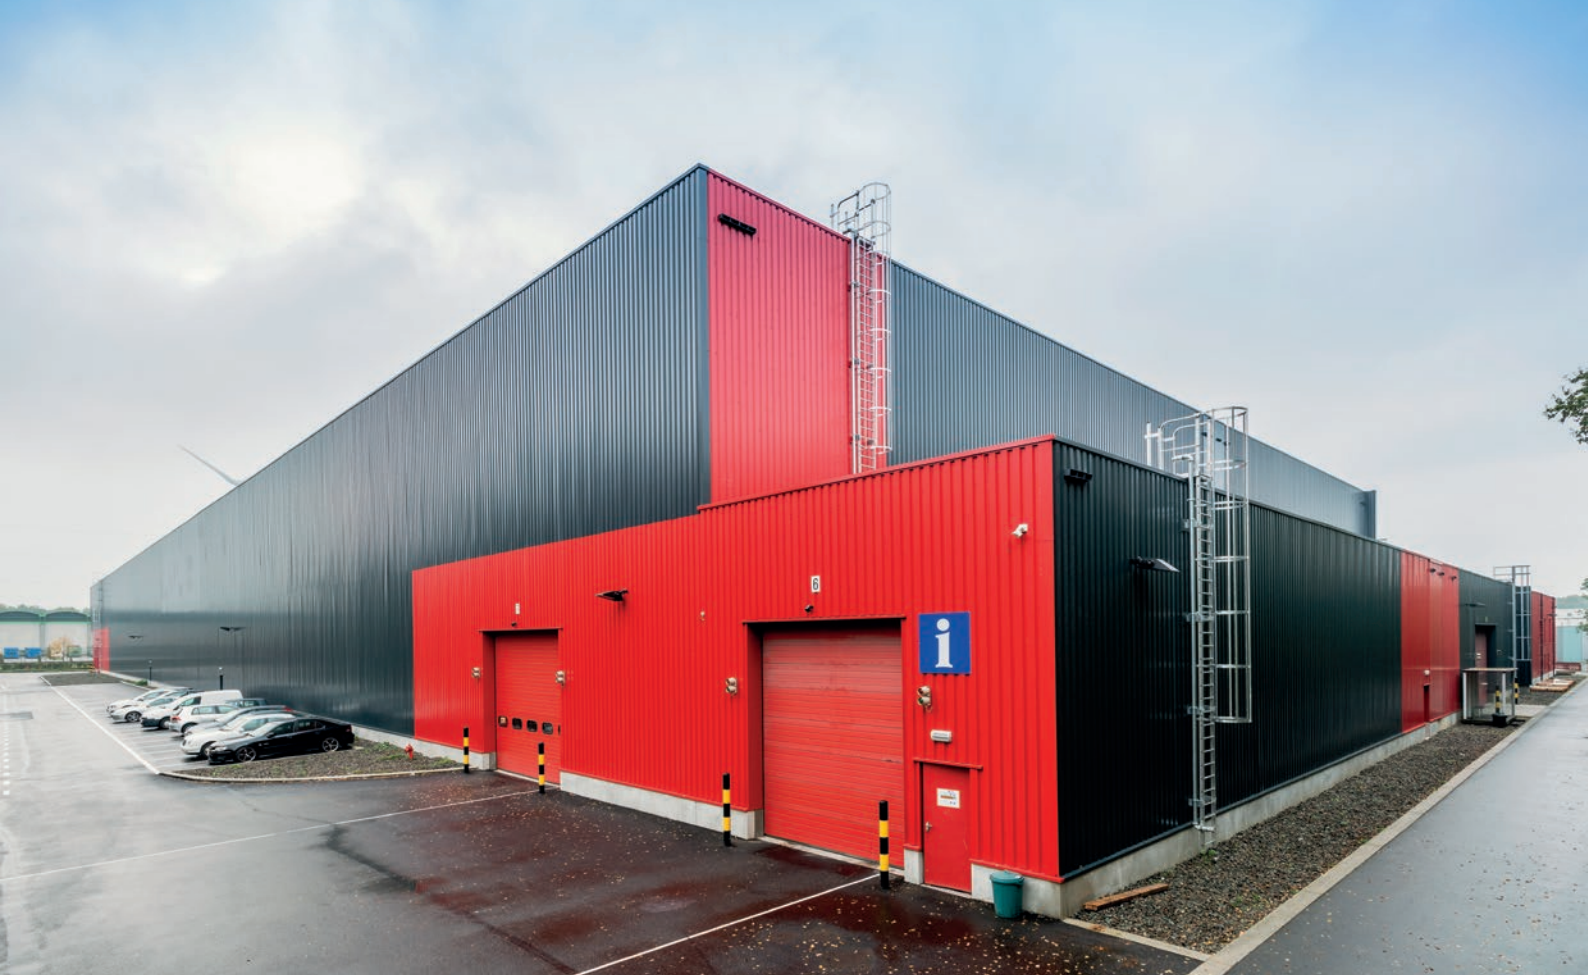
▲ Roba Metals Genk extended its stainless steel and aluminium service unit by 5000 m<sup>2</sup>.

Extension of the stainless steel and aluminium service unit:

- 416 tonnes steel, 5250 m<sup>2</sup> steel deck, 2322 m<sup>2</sup> reused and 806 m<sup>2</sup> new insulated steel sheets, and 4657 m<sup>2</sup> fire resistant aerated concrete walls.
- Supply and installation of logistics infrastructure:
  - 167 metres of new Burbach rails with expansion joints, including new conductor lines.
  - 2 new 28-metres 15-tonnes overhead cranes with appropriate coil and sheet metal tongs.
  - A new 27-tonnes coil and sheet transfer car equipped with automatic control and obstacle/person detection. Installation included rails and foundations over a 50m track length
  - Relocating an existing overhead crane into the new building and renewing radio control on all existing cranes for conformity and operator convenience.

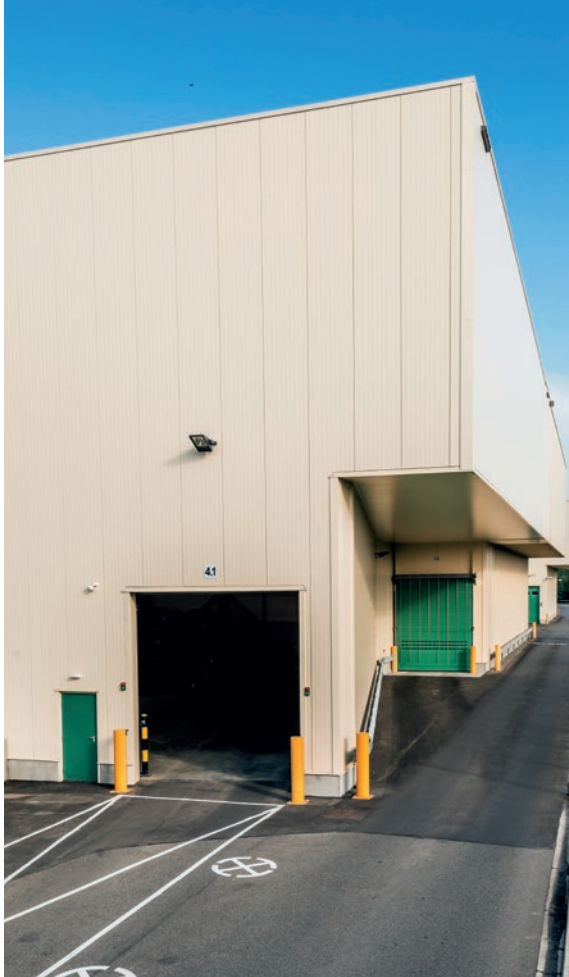
- ◀ The new steel coil and sheet storage facility strengthened Roba Metals' competitiveness.

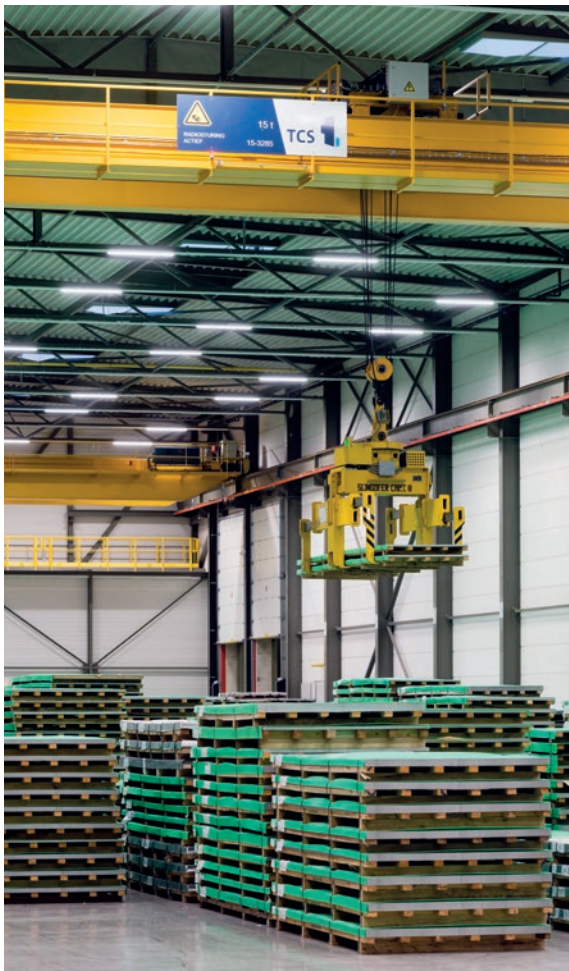
- ◀ A series of new overhead cranes with appropriate coil and sheet metal tongs were installed.

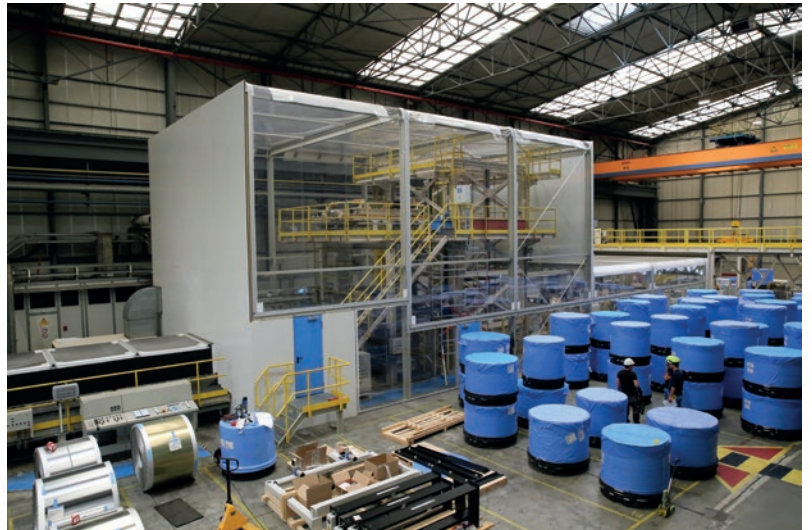
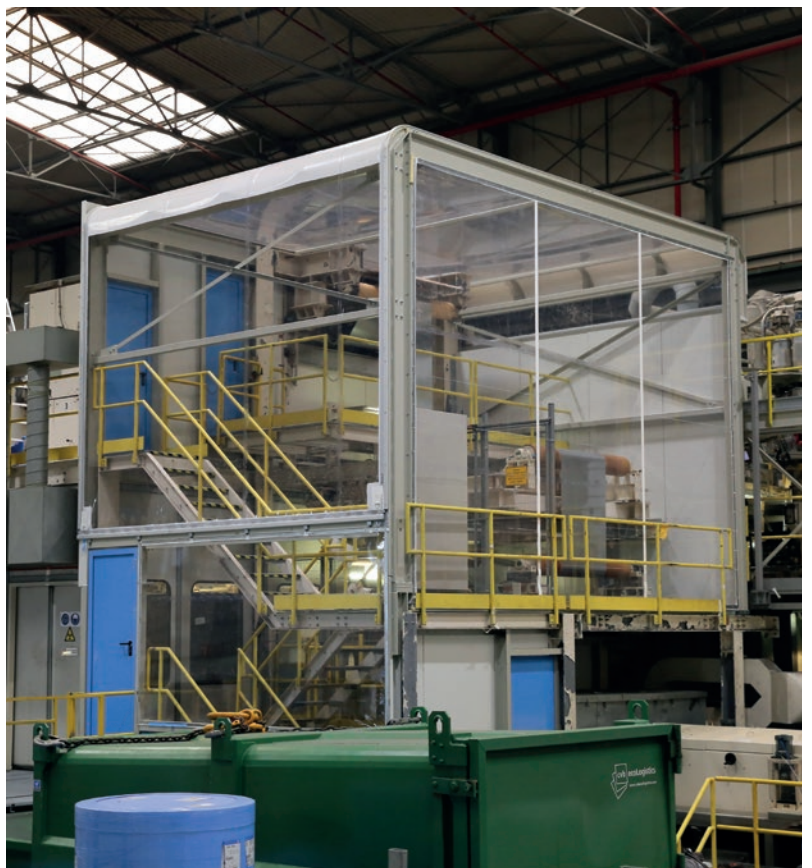
The system consists of a modular steel framework with transparent flexible plastic sheeting that can be put up and taken down easily. ▼

Known as TEPE (Total Enclosed Protact® Environment), the system consists of a modular steel framework with transparent flexible plastic sheeting that can be installed and removed easily. 12 metres wide and 10 metres high, it protects the production line over a length of 40 metres, without unwanted side-effects. Borremans confirms: “Working conditions are much better than they were in the old set-up, with everyone having a perfect view over the entire process. Quality is significantly better, because of the improved sealed setup, and cleaning and maintenance can be organised zone by zone, leading to minimal production downtime. It’s amazing how well it works. I’m sure the solution will find its way into other production environments too.” ■

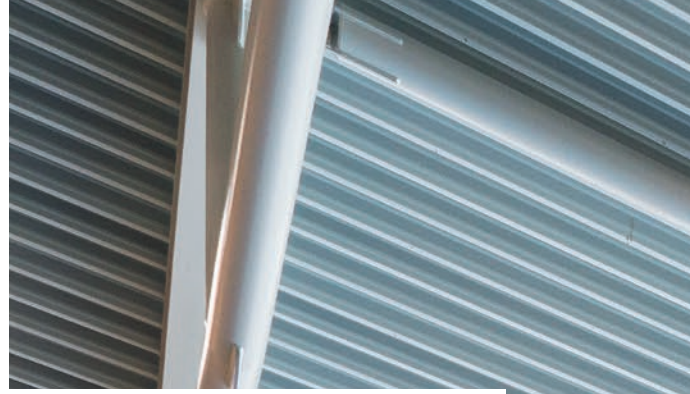
▶ The structures of both the gym and the sports are based on HEB400 columns spanned by 33.4-metre inverted bowstrings.

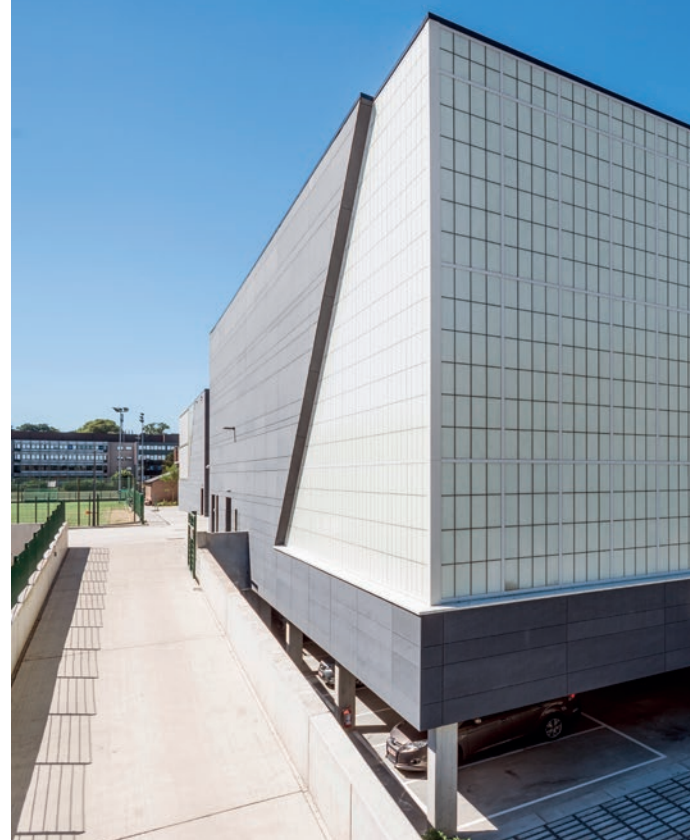
▲ The translucent wall panels bring in a lot of daylight and make for a unique facade.

The sports centre itself includes a 25m swimming pool, dance studio, fitness suite, gym, and multi-purpose sports hall, as well as a cafeteria and a large examination space. Leyskens elaborates on the architectural challenges: “It is a fairly complicated cluster of different functions. For this reason, a fair number of the spaces were designed with a maximum functional flexibility to meet changing needs in the future. The building’s lightweight steel structure adds to the flexibility. At the same time, we also wanted to bring a lot of daylight into the gym and sports hall to improve comfort and reduce the energy needed for lighting. But this meant we had to avoid unpleasant shadows and glare, so we decided to use translucent wall panels to bring in diffuse light in a controlled manner. By the way, this also makes for a unique and elegant look from the outside!”

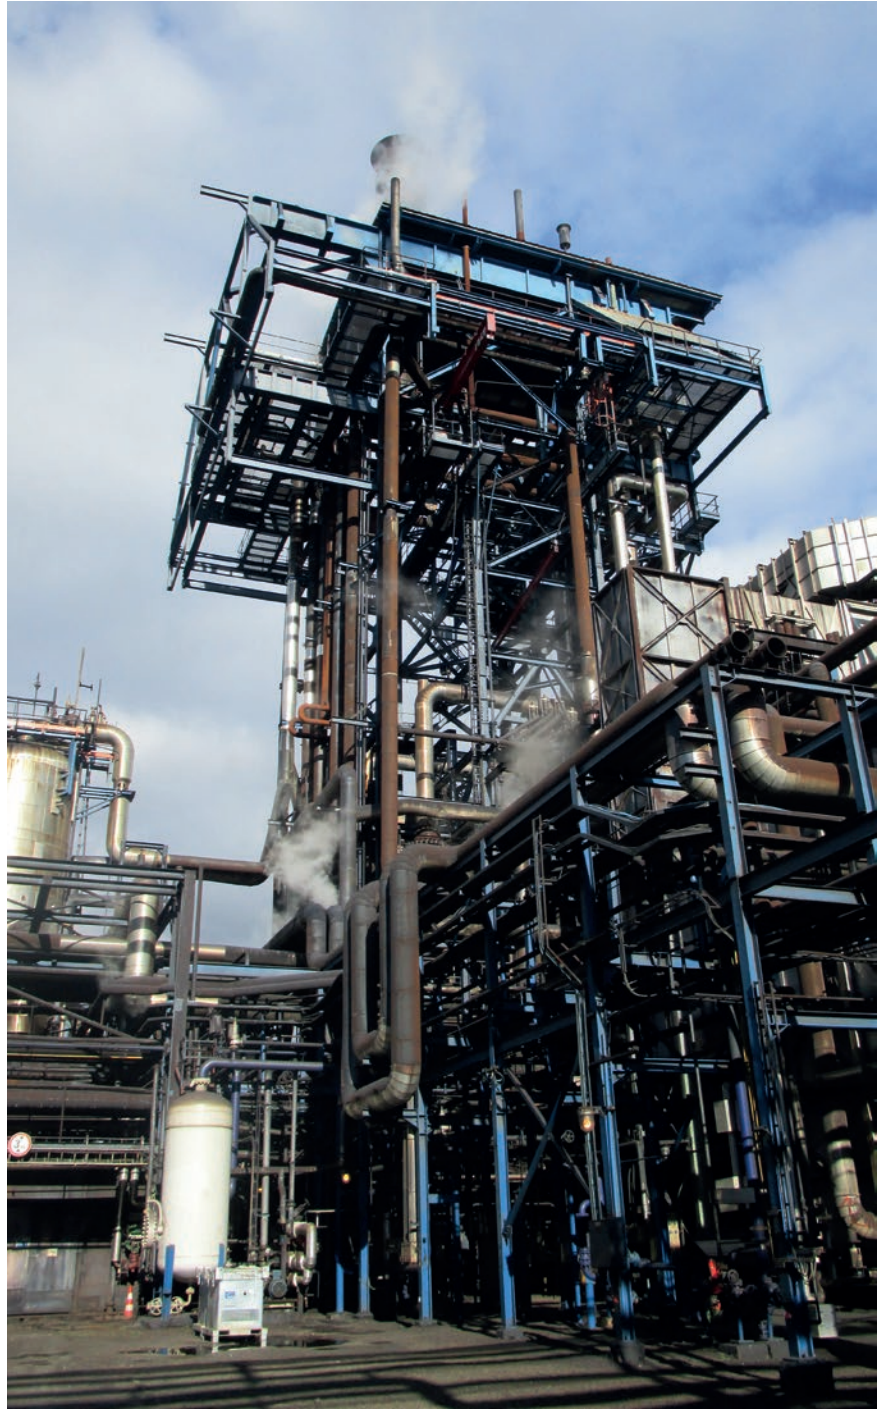
- The 50+-year old steel structure housing the Yara Tertre reformer is being renovated.
- A comprehensive measurement campaign and a structural analysis were carried out to identify the elements needing repair or replacement.
- Scenarios were developed to allow renovation while production continued.

A lifetime assessment programme has been carried out on all the steel structures at the site. One of the structures under scrutiny was the 10m by 10m tower housing the plant’s primary reformer, a furnace that converts natural gas into gaseous hydrogen for the eventual production of ammonia. “Analysis revealed severe degradation and structural weaknesses, mostly resulting from the year-round exposure to aggressive substances in the ammonia production process,” says Cattry.

- Dismantling and replacing steel structures in the tower, including 150 beams (25 tonnes).
- Removing and replacing 2 tonnes of staircases, 8.7 tonnes of stair and platform handrails and 382 m<sup>2</sup> gratings.

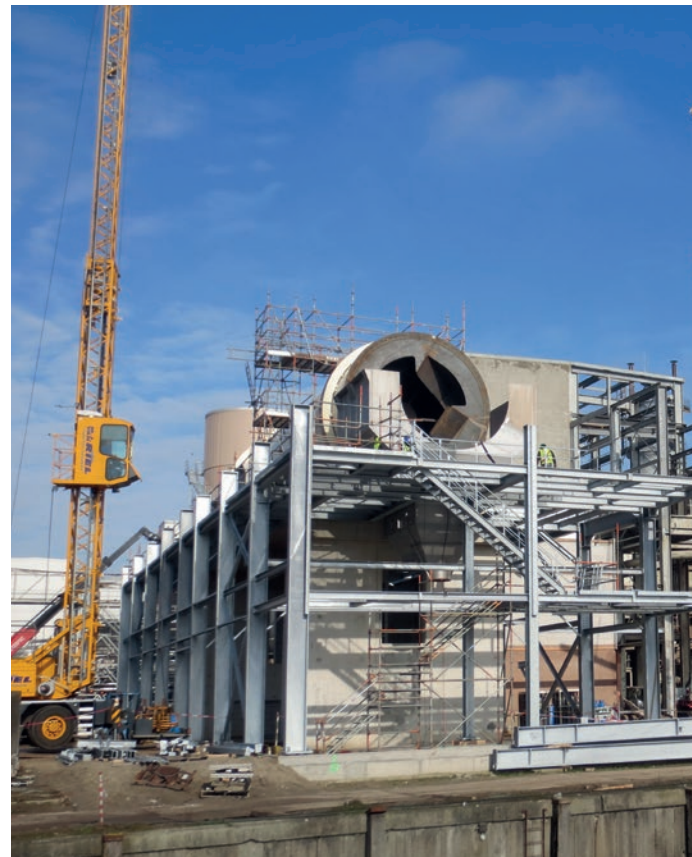
▲ The extension of the sugar beet washing line is the final stage of the plant's modernisation plan.

- The Suiker Unie sugar factory in Dinteloord, the Netherlands, is significantly increasing the capacity of its beet washing line.
- The project is the final stage of Suiker Unie's masterplan to prepare for the post-quota era of EU sugar production, making it one of the most efficient, productive and sustainable sugar factories in Europe.

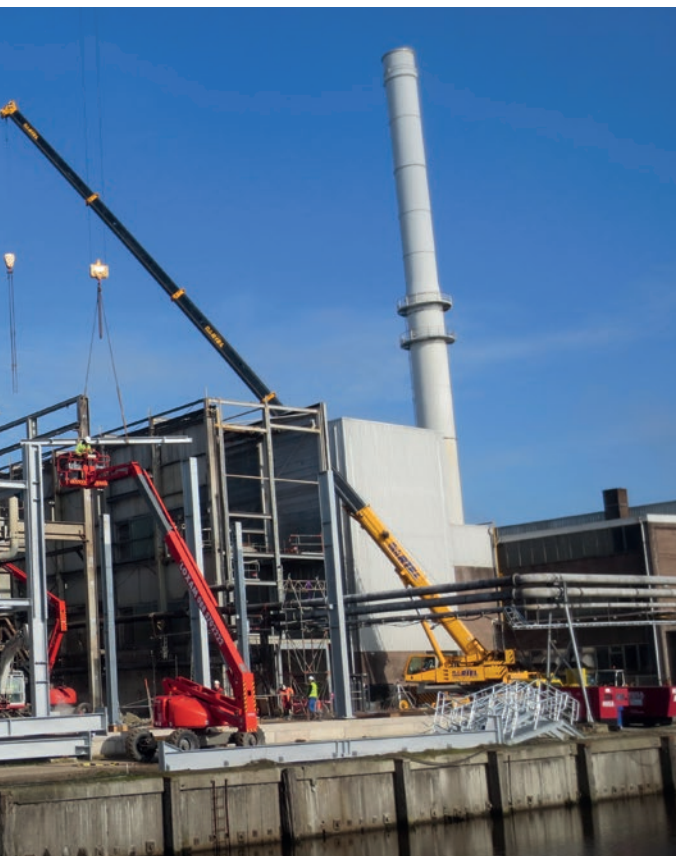
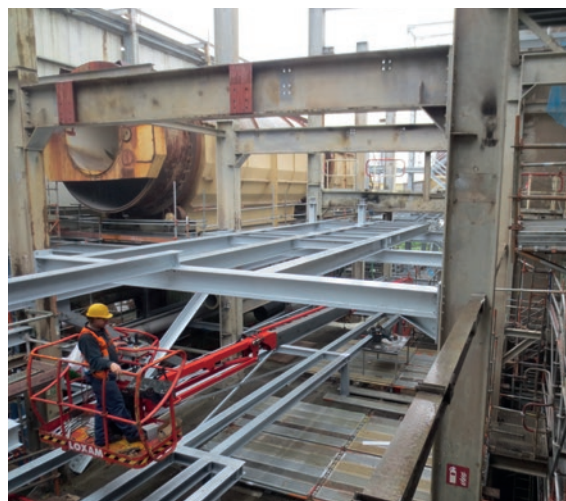
◀ The design needed to be meticulously engineered, given the structural vibrations induced by the washing equipment.

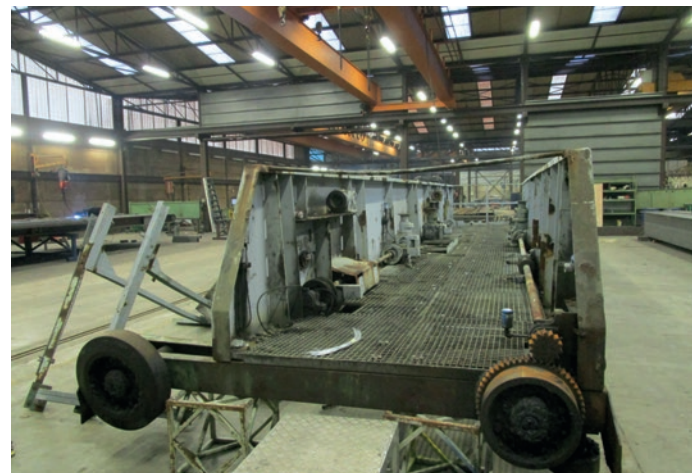
▲ The equipment was designed to carefully skim the oil accumulating at the surface of a 30m x 6m wastewater basin.

**T**he two oil skimmers had been installed 50 years earlier as part of Total's wastewater treatment installation at their Antwerp refinery. They were designed to carefully skim the oil accumulating at the surface of two 30m x 6m wastewater basins so that it could be reinjected into the crude oil stream. Some years ago, one of the skimmers had broken down and was replaced by a completely new one, and this second one proved more resilient. Nevertheless, inspection revealed severe signs of wear and tear after its long period of useful operation, so a thorough renovation of both mechanical and electrical parts was due.

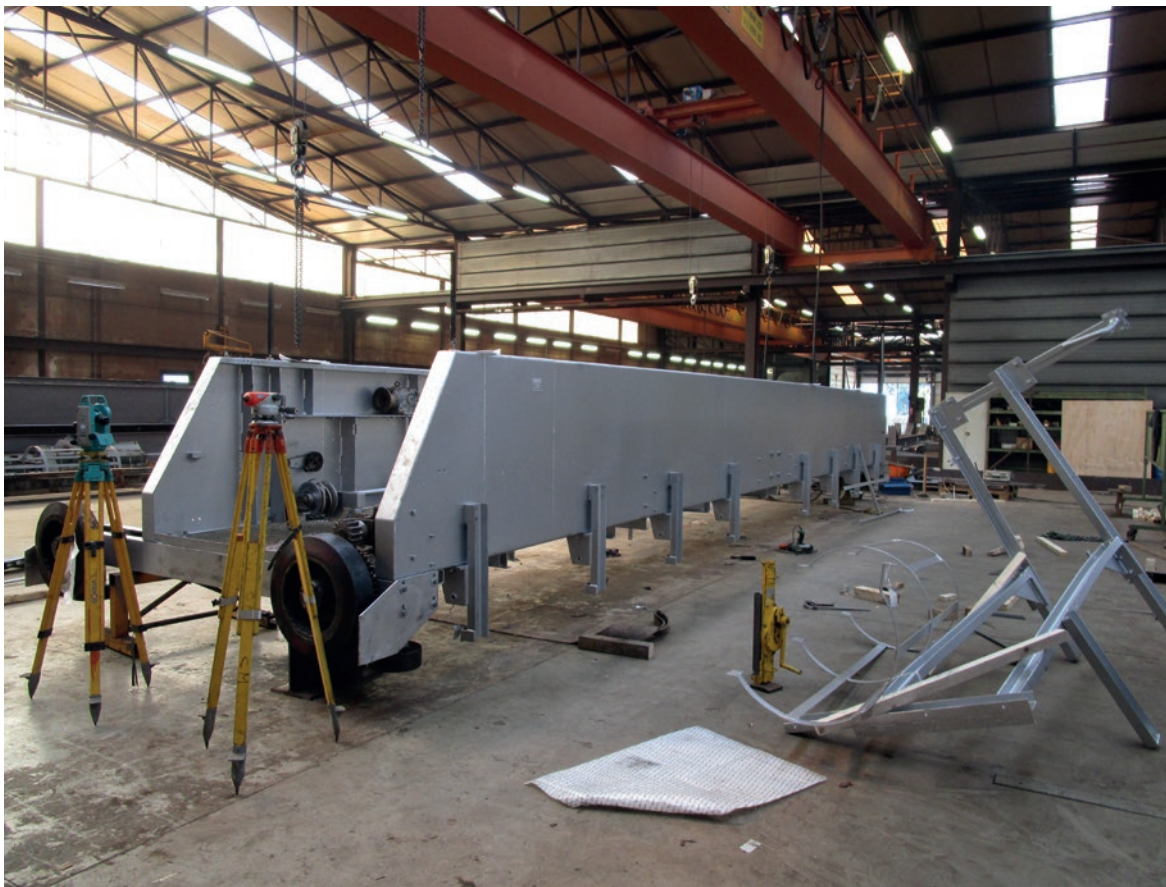
◀ Renovation work was monitored scrupulously by Total quality control staff.

- Renovation of a 12-metre piece with a painting surface of 100 m<sup>2</sup> and approximately 24 m<sup>2</sup> of gratings.
- Stepwise approach, allowing for maximum re-use of material:
  - Disassembly of all parts.
  - Cleaning of all parts to allow inspection of transmissions, cables, bearings et cetera.
  - Sandblasting of the structure to lay bare the steel for inspection (deformation, corrosion, damage).
  - Renewing all worn-out parts.
  - Assembly at the workshop and transportation in one piece to the site.

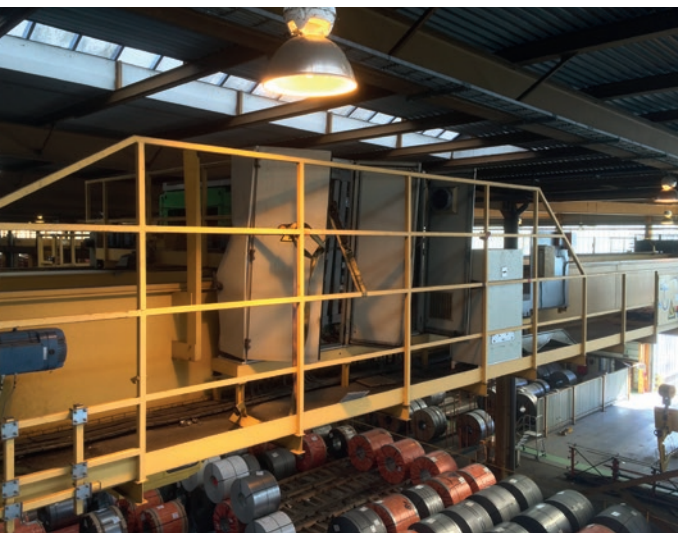
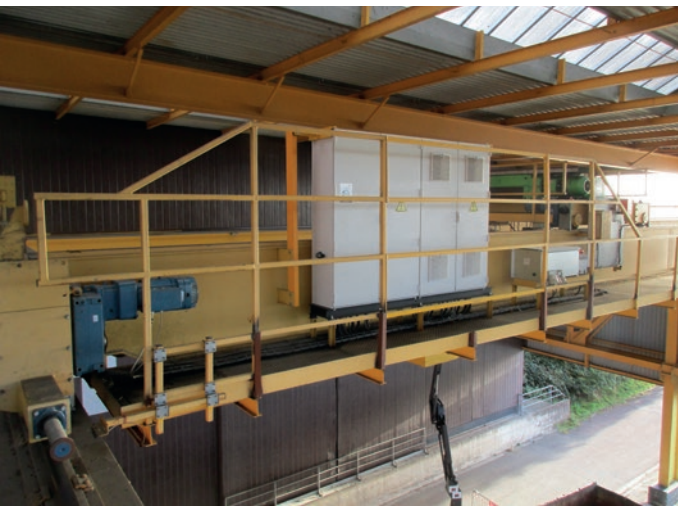
◀ The crane’s PLC was renewed, the drives and damaged parts replaced, and the mechanism to prevent collision with the gate redesigned.

they also showed us that the severity of the mechanical damage meant that a more radical overhaul was needed to prevent further wear and tear. Even more importantly, they identified a weakness in the original 2001 safety mechanism. This led them to propose a comprehensive system upgrade with state-of-the-art technology, including renewal of the crane PLC, replacement of the drives and damaged parts, and a redesign of the collision prevention mechanism.”

- 32-tonnes 23.5-metres overhead travelling coil crane
- Replacement of the complete electrical enclosures 2 x RITTAL TS 1200 x 1800 x 400
- Drives ABB ACS 850
- Schneider PLC TM 241
- Safety PLC PILZ PNOZ MULTI
- Improvement of interface with gate in building using a radio transmission of signals with HBC-radiomatic GEOX

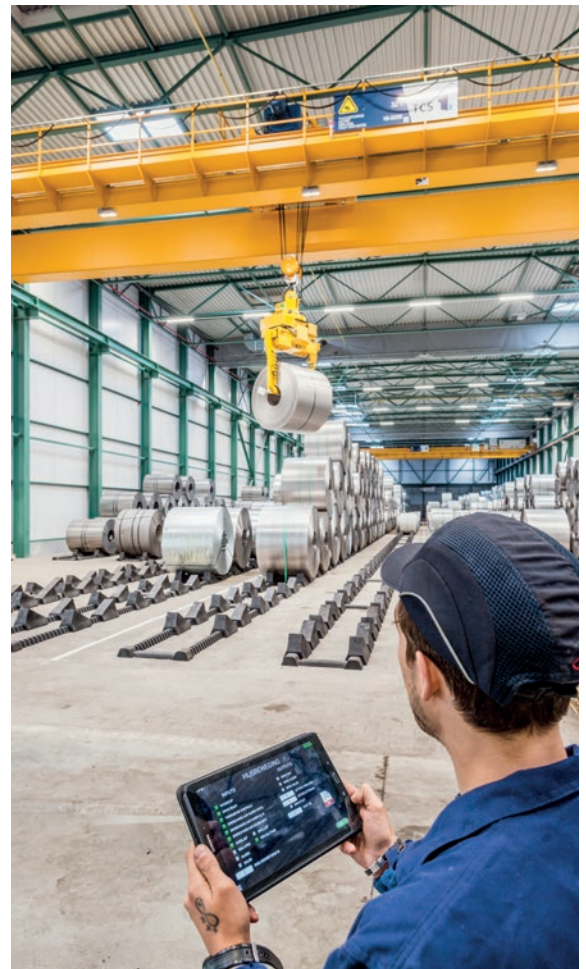
▲ All investigations can be made from below while operating the crane.

The tool was developed to give customers more control over their crane fleet, especially when faced with a performance issue or other malfunction. “We started to think about this during talks with customers,” explains Carlo Grootaers, head of the TCS Cranes Business Unit. “Many of them have their own onsite maintenance teams, with the experience and skills to carry out most corrective interventions. However, they find that the diagnosis of problems is difficult and time-consuming. And they are right. For example, a lifting performance problem could be caused by a defective signal, a switching error or a frequency controller issue. It would require a maintenance person to get up onto the crane and check all the parameters to identify the cause.”
